Manhole Inspection Summary

Manhole # S25I__060MH

Insp Date: **4/1/09 10:14 AM**

Location Address: **Holton Alley**

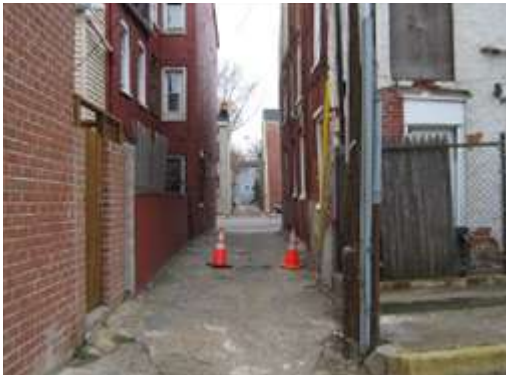
Location View

Holten Alley

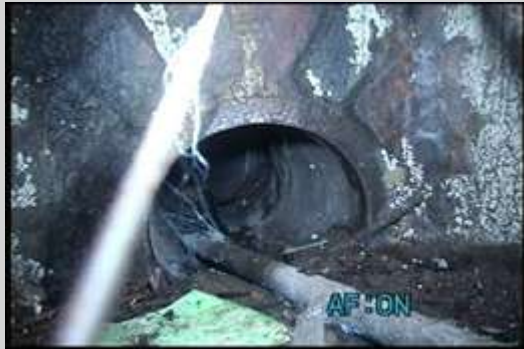
12 O'Clock Outflow

8 in. Circular Gravity Sewer
Pipe Out @ 12 O'Clock

Pipe Height: **7.2** (in.) Rod and Bar (Angled)

Pipe Material: **Clay** ☐ Pipe Lined

Infiltration: **None** Pipe Seal Cond: **Sound**
